Pentium® II Xeon™ Processor Specification Update

Release Date: June 1998

Order Number: 243776-001

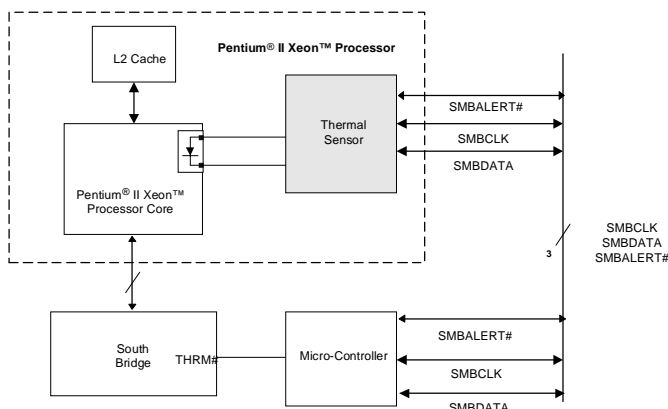
Figure 1. An Example of Micro-controller Driven Thermal Management

PROBLEM: The Pentium II Xeon processor has a thermal sensor that monitors the processor core's temperature. The thermal sensor asserts SMBALERT# if the processor temperature exceeds the temperature limits set in the Alarm Threshold Registers (T_{HIGH} , T_{LOW}). It also sets the corresponding Status Register bits to identify the cause of the interrupt. Figure 1 gives one example of the how the SMBALERT# signal could be used in a system.

Under the conditions described below, the thermal sensor incorrectly generates the SMBALERT# interrupt. **All** of the following conditions must be met to trigger a false interrupt:
